1.2 Airport Inventory

1.3 Airside Facility & Pavement Inspection

1.4 Structural Building Assessment

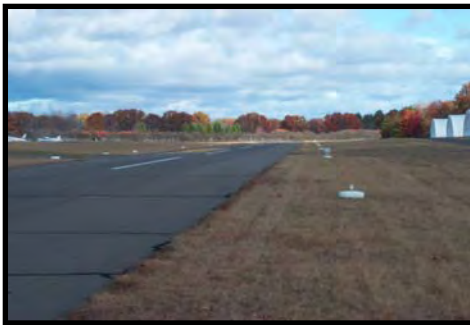
TABLE 1-3 – EXISTING CONDITIONS			
Airside Facility	Condition	Issues	Short-Term Recommendation
Runway 3-21	Fair	Isolated longitudinal cracking (1/2' to 3/4" wide) along the pavement joints, transverse cracking (3/4" to 4" wide) along entire length of Runway 3-21	Saw cut existing cracks, Fill cracks with pavement
Main Apron (near office)/Hangars	Good	Isolated Transverse and longitudinal cracking (3/4" wide)	Seal cracks
Taxiway (1)	Good	Isolated Transverse and longitudinal cracking (3/4" wide)	Seal cracks
Taxiway (2)	Good	Isolated ponding	None

Runway Transverse Cracking

In the short-term, all of the Airport's paved areas can be adequately repaired with crack sealing or other minor rehabilitation. However, the runway will likely require a reconstruction and the taxiway and apron pavements will likely require a "mill & overlay" (rehabilitation) within the next 10 years.

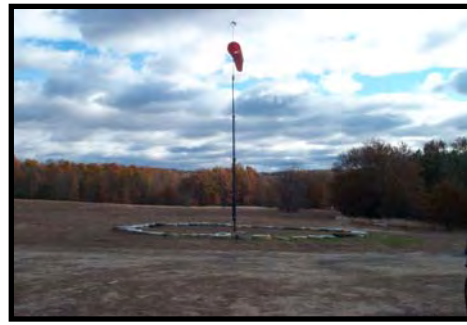
Segmented Circle

- Install lighting consistent with FAA Standards
- Paved segmented circle
- Install runway hold position markings and signage
- Paint taxiway centerline markings
- Existing drainage system maintenance
- Pave driveway to fabric hangars

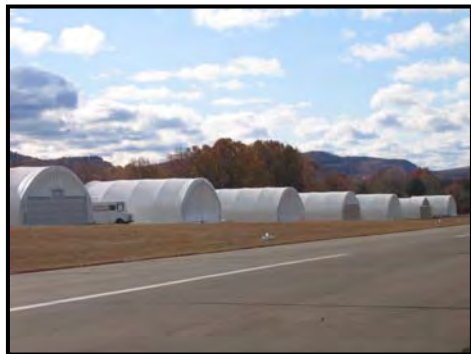
As shown in Table 1-4, most of the structures at Simsbury Airport are in poor condition and require significant repairs. Some of the repairs are needed for structural and safety reasons. The Town would need to fund the preliminary repair costs, unless ARA completed repairs on the buildings owned by the ARA prior to the sale of the Airport (which could be negotiated as part of the purchase agreement). The Airport Capital Improvement Plan (Section 2.3) lists the phasing, cost estimates, and funding source for each recommendation.

Fabric Hangars

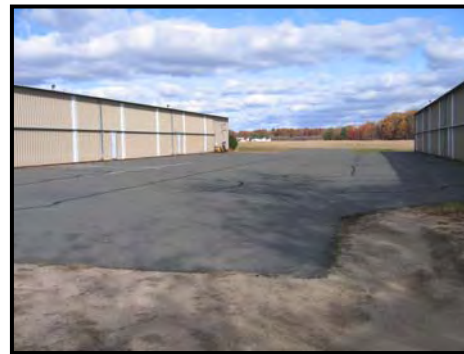
T-Hangars
